Water Compliance Inspection Report

**NPDES
Inspection Report**

**Baker Hughes Oilfield Operations, Inc.
(NPDES Permit #: AKR06AD08)**

May 23, 2017

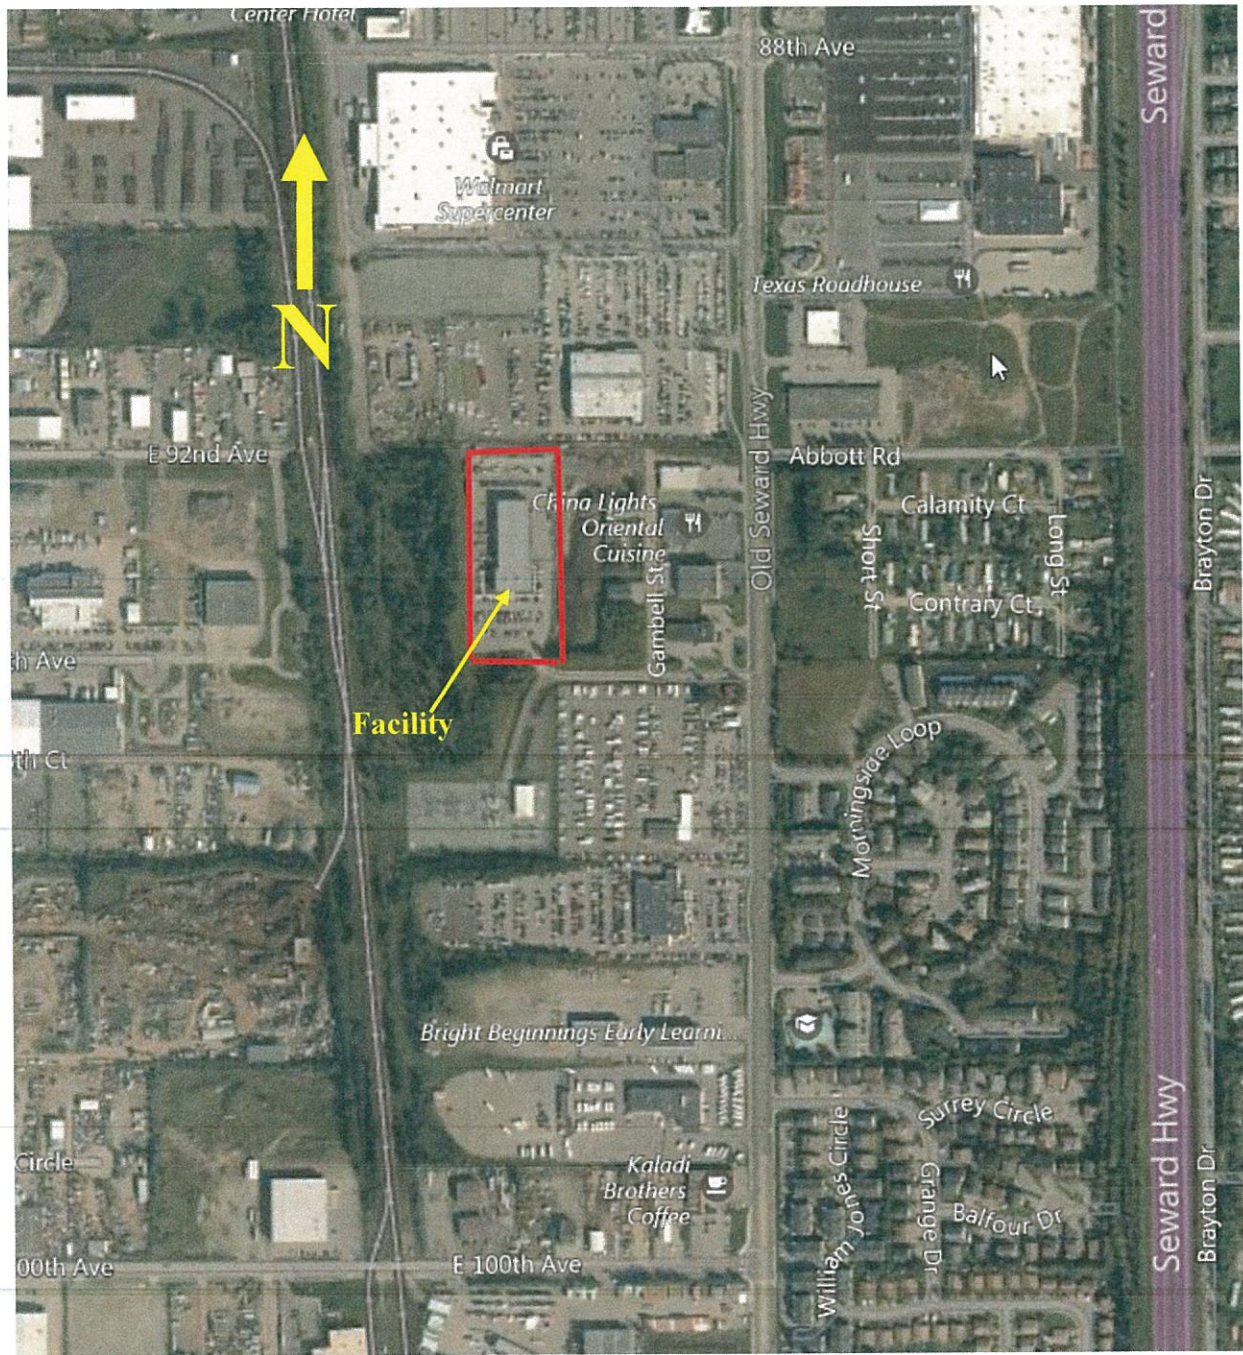
Aerial Image (B-1)

Runoff from the facility parking lot (located along the south side of the facility) flows in a northerly direction and enters drains located on the east and west sides of the office building. See Attachment B-2 of this report for details regarding the approximate location of these parking lot drains.

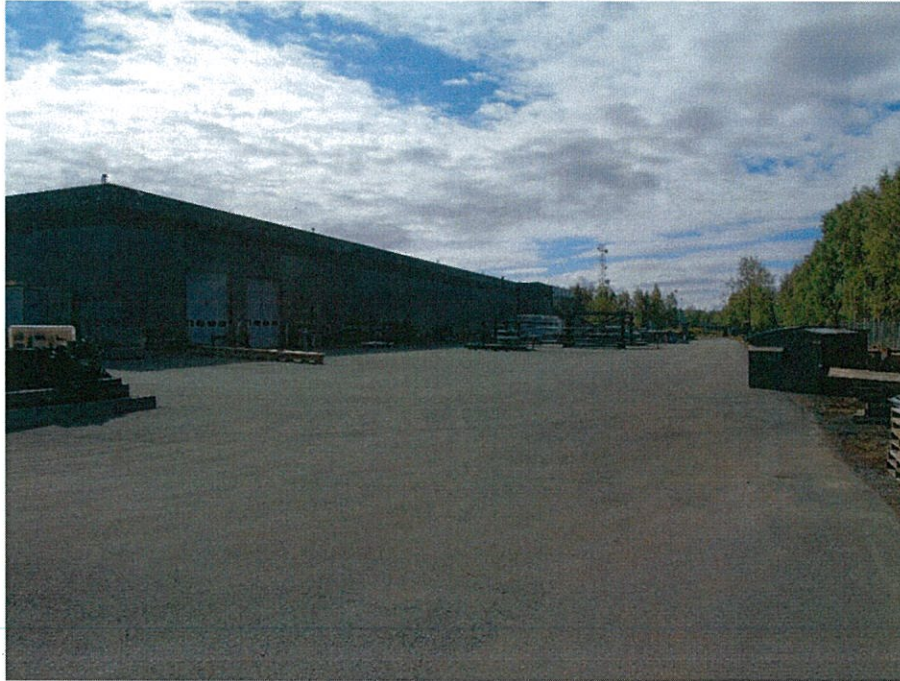
Photo #1: Southerly view which shows the west side of the shop/office building. Note the equipment storage adjacent to the building. Camera photograph #DSC05505.JPG.

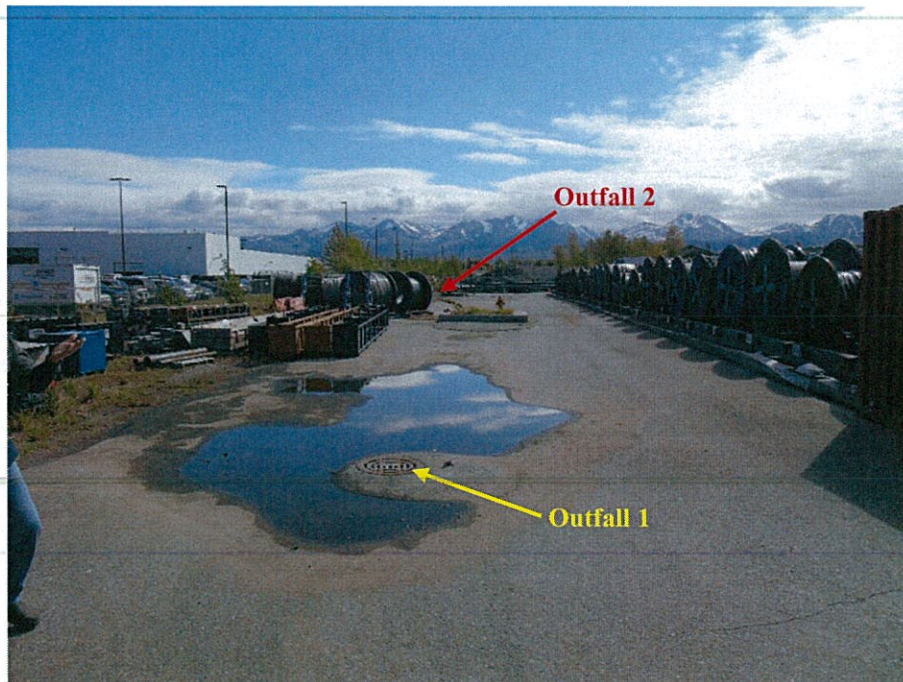
Photo #2: Easterly view showing outfall 1 in the foreground and the vicinity of outfall 2 in the background. Also note the equipment storage in the vicinity of these outfalls. Camera photograph #DSC05507.JPG.

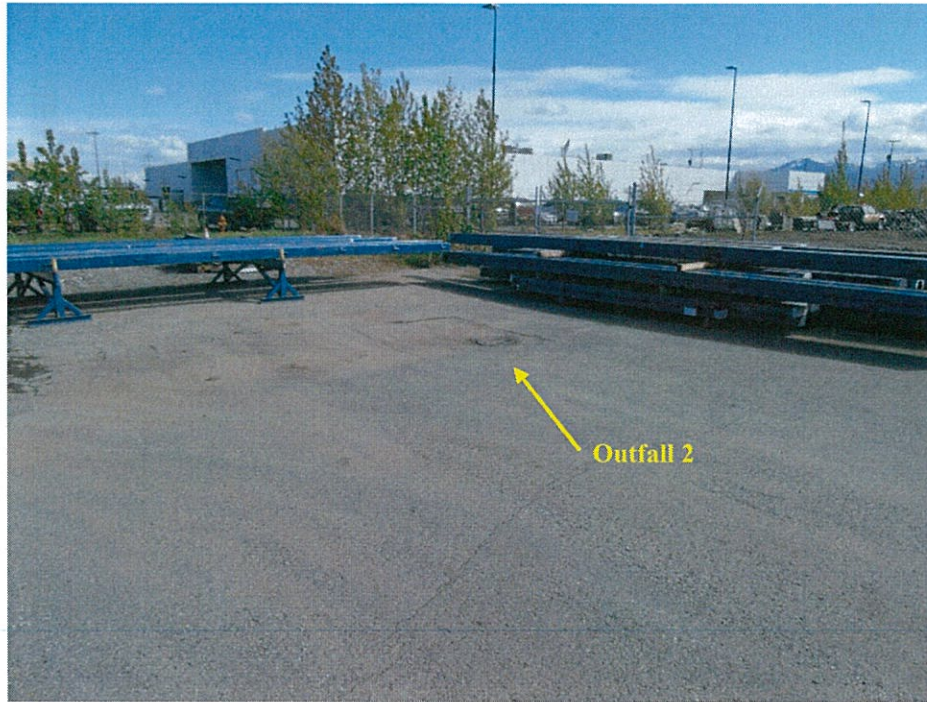
Photo #3: Northeasterly view showing outfall 2. Note the equipment storage in the vicinity of this outfall. Camera photograph #DSC05508.

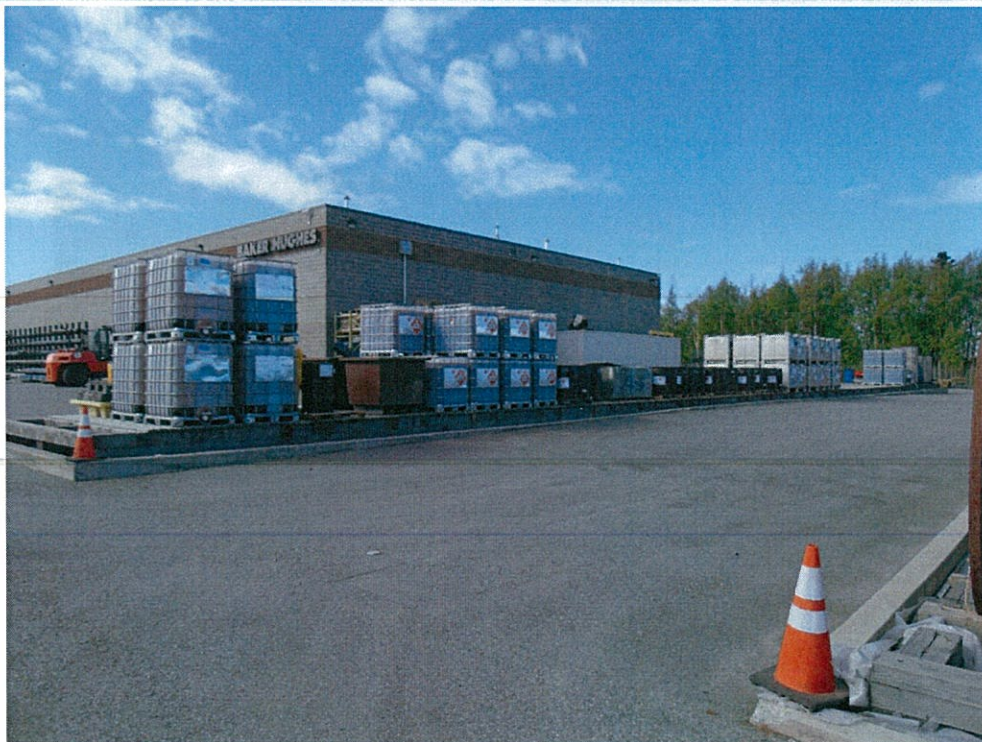
Photo #4: Southwesterly view showing the chemical storage area. Note the secondary containment in this area. Camera photograph #DSC05509.

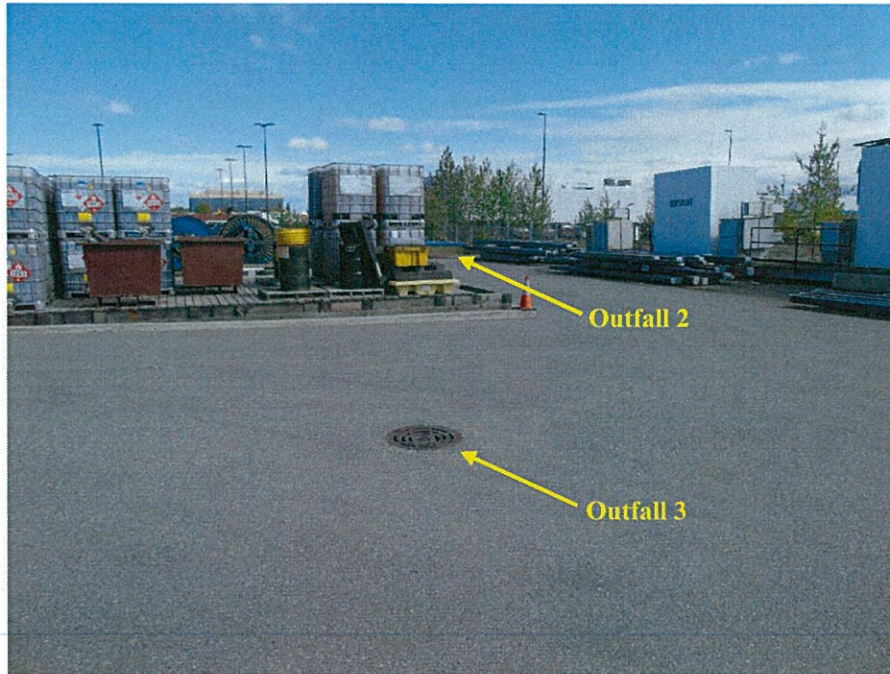
Photo #5: Northeasterly view showing outfall 3 in the foreground, the chemical storage area on the left, and the vicinity of outfall 2 in the background. Camera photograph #DSC05512.JPG.

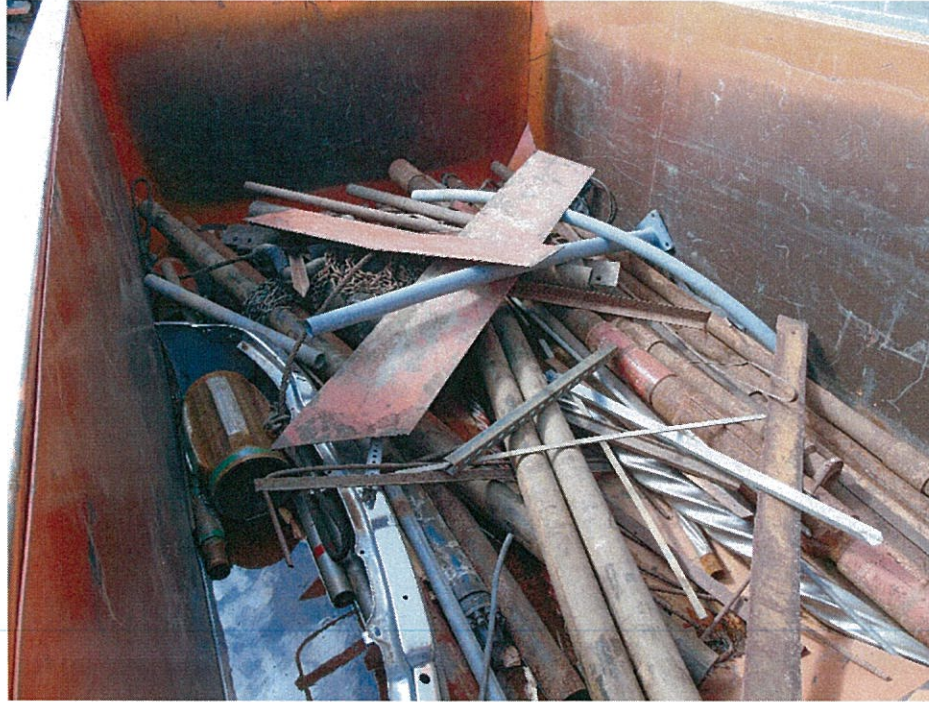
Photo #7: View inside the dumpster shown in the previous photograph. Camera photograph #DSC05511.

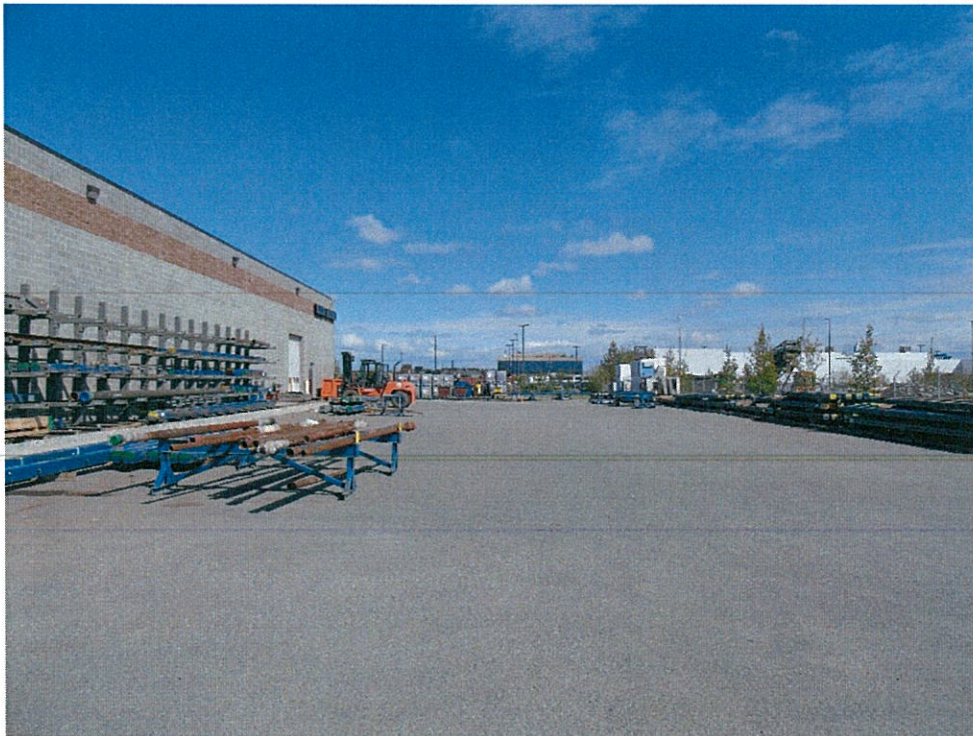
Photo #8: Northerly view showing the east side of the shop on the left. Note the equipment storage in this area. Camera photograph #DSC05513.
